FINAL REPORT

PHASE I INVESTIGATION OF SCUBA CYLINDER CORROSION

N. C. Henderson, W. E. Berry,
R. J. Eiber, and D. W. Frink

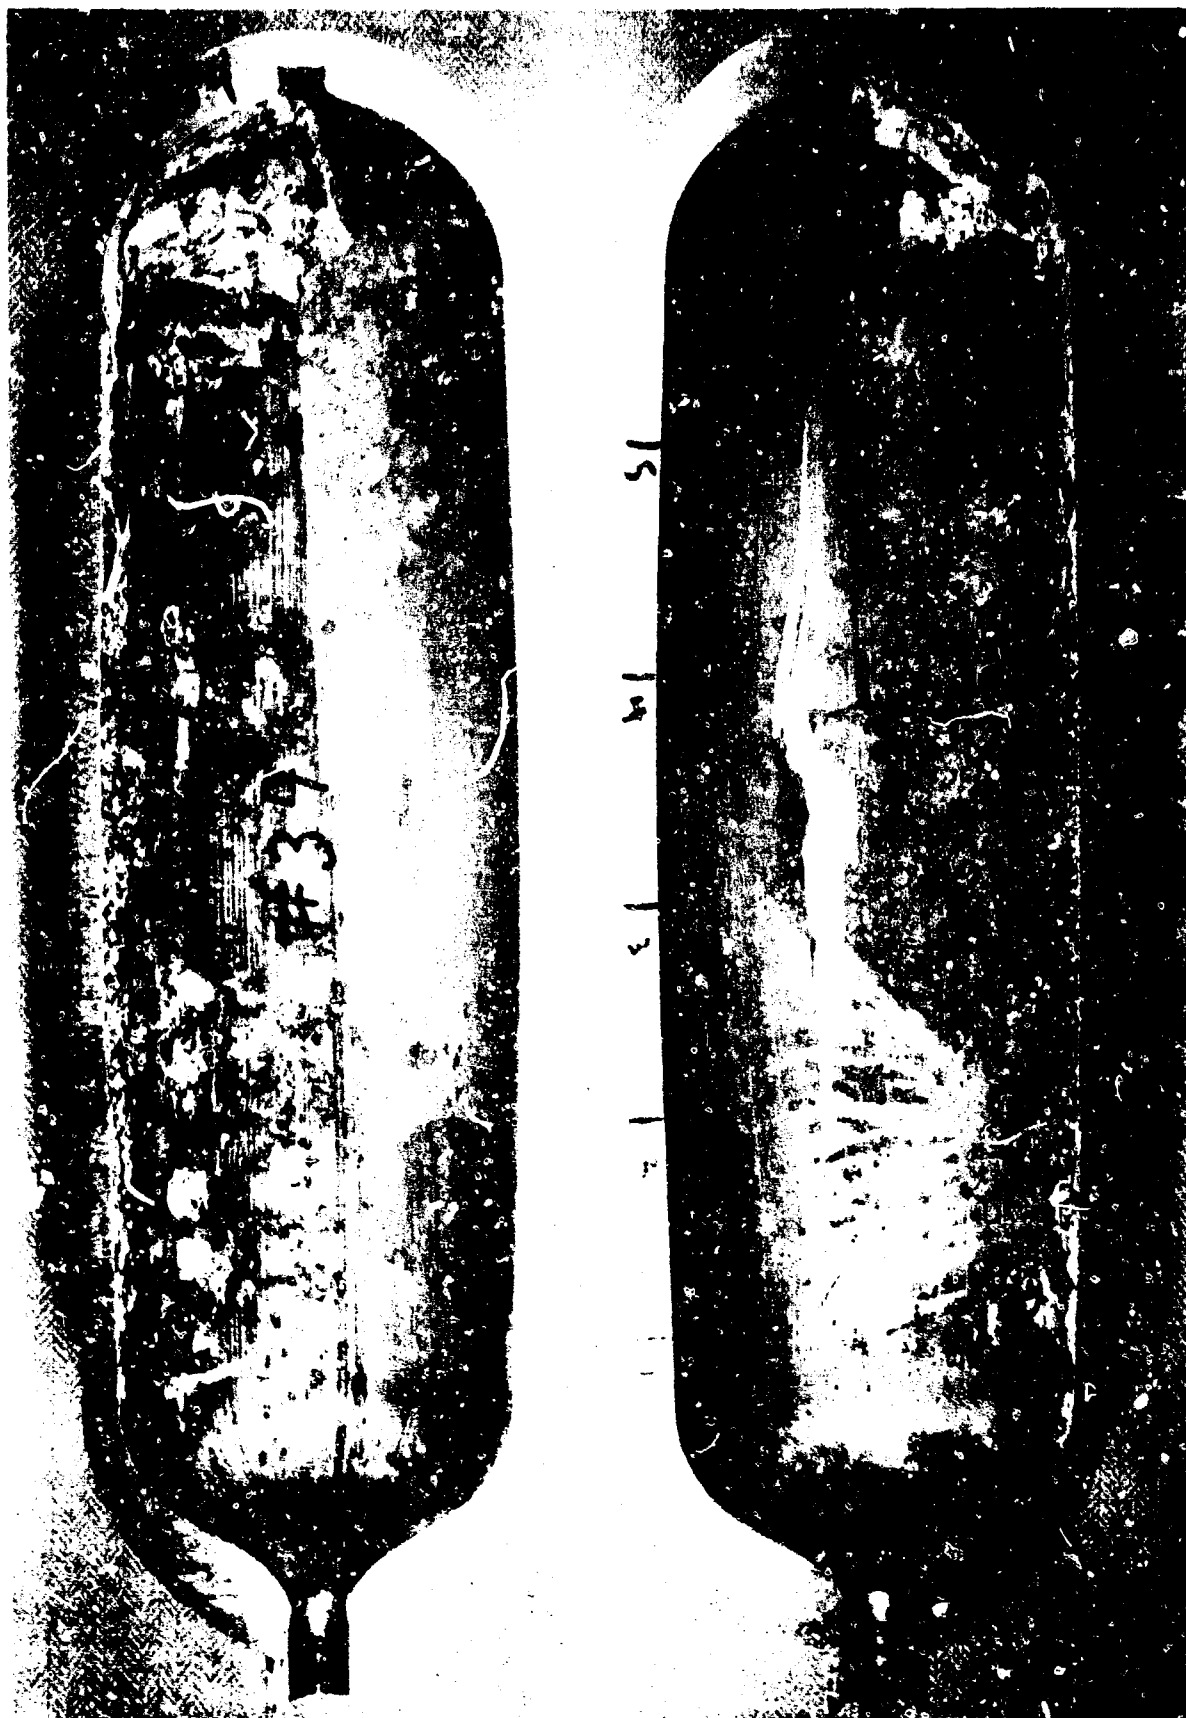
FIGURE 9. CORROSION IN CYLINDER 34

Characterization of Corrosion in Ruptured Cylinders. Figures 9, 10, and 11 show the corrosion on the inside of Cylinders 34, 57, and 64 following

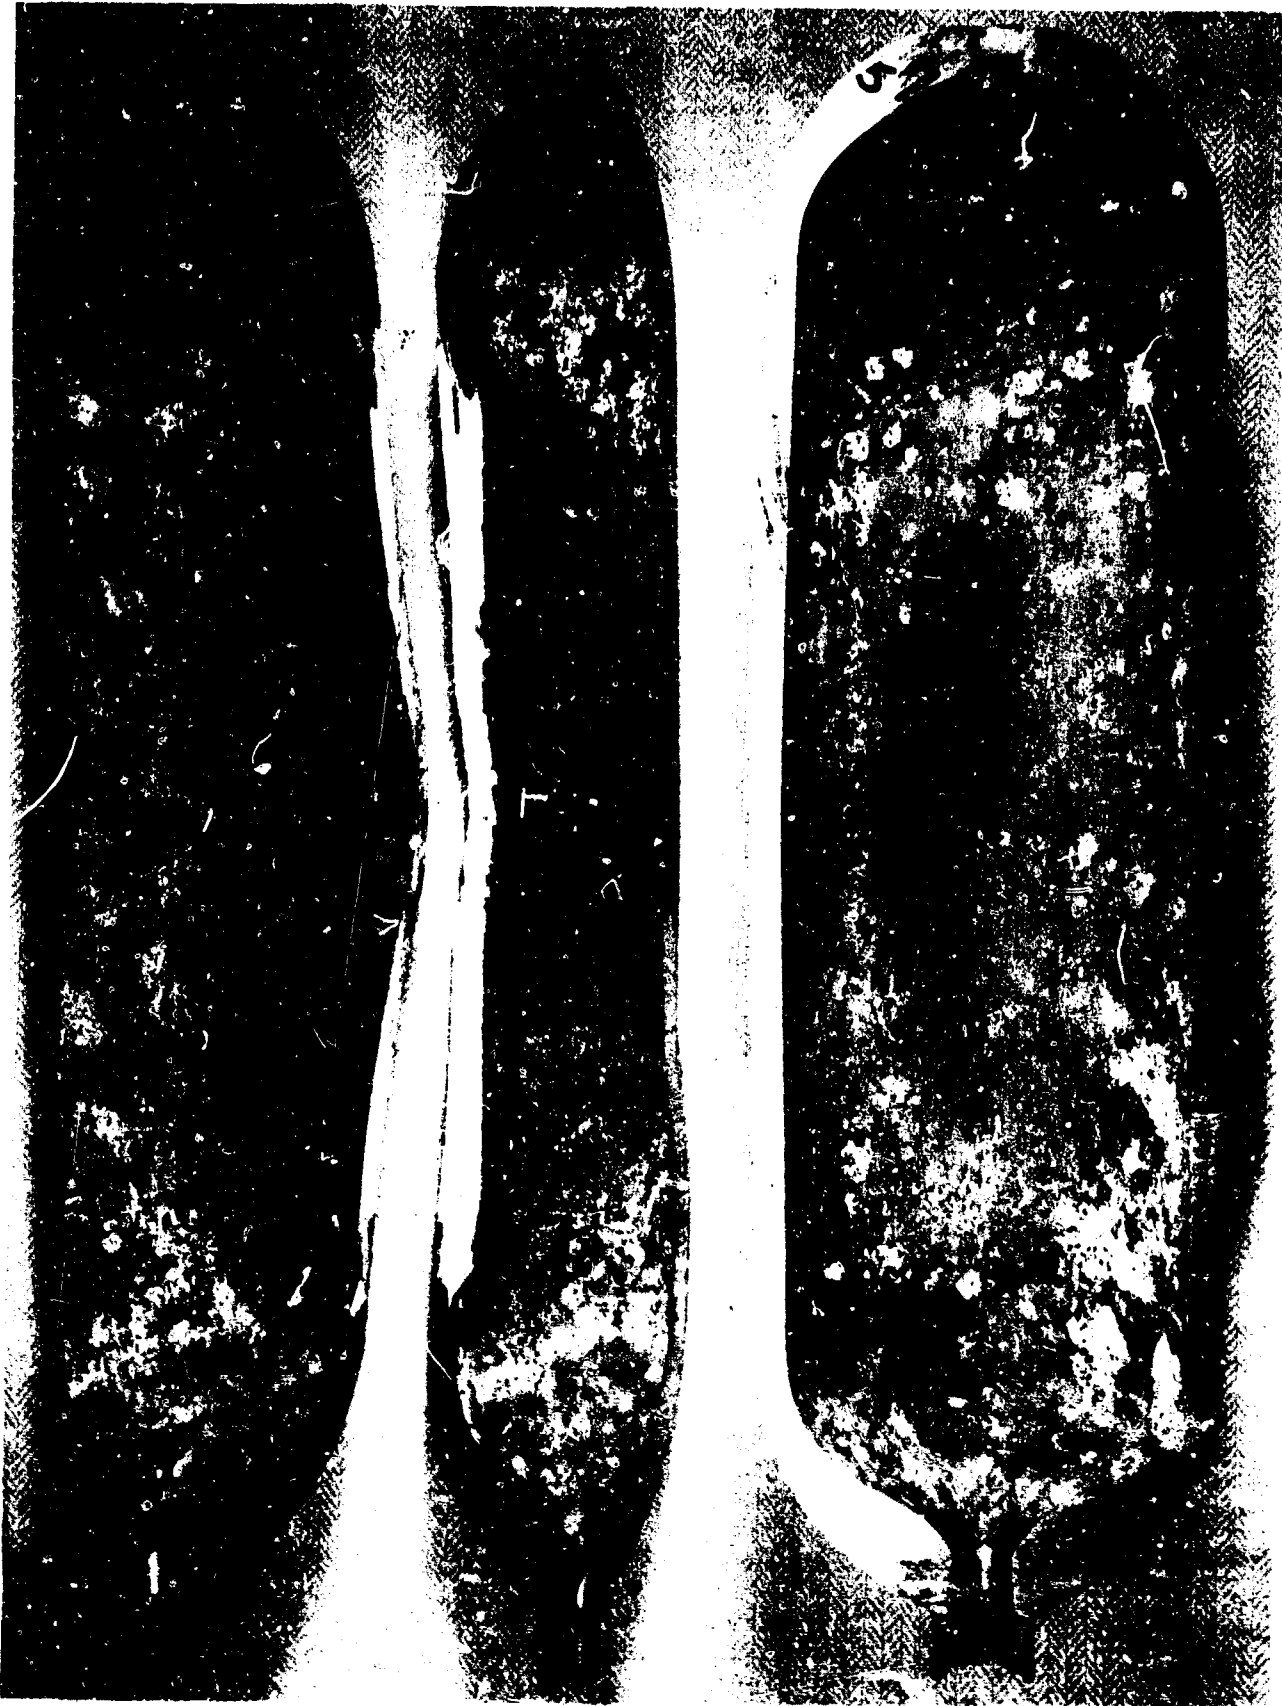
FIGURE 10. CORROSION IN CYLINDER 57

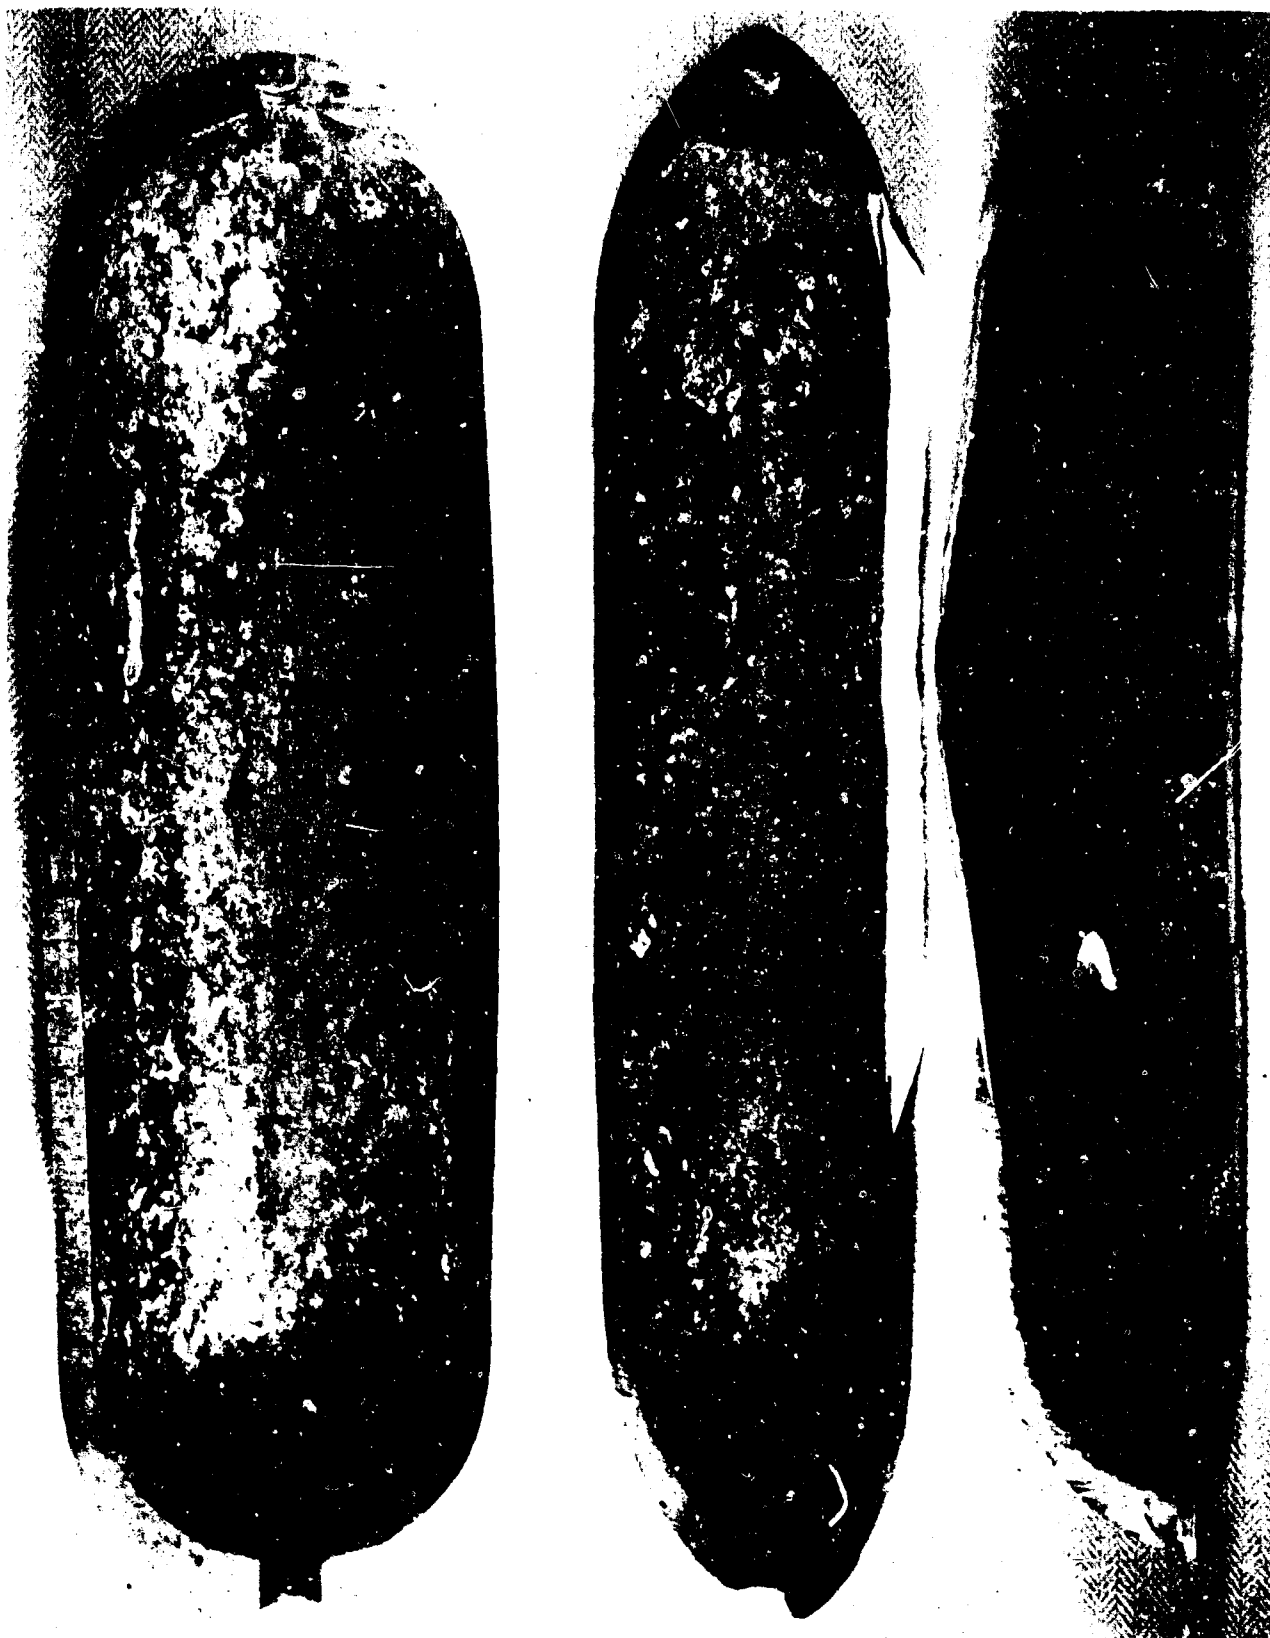
FIGURE 11. CORROSION IN CYLINDER 64
